# Creep and environmental durability of EBC/CMCs under imposed thermal gradient conditions

Matthew Appleby, Dr. Gregory N. Morscher – Department of Mechanical Engineering, The University of Akron, Akron, OH  
Dr. Dongming Zhu - Durability and Protective Coatings Branch, NASA Glenn Research Center, Cleveland, OH

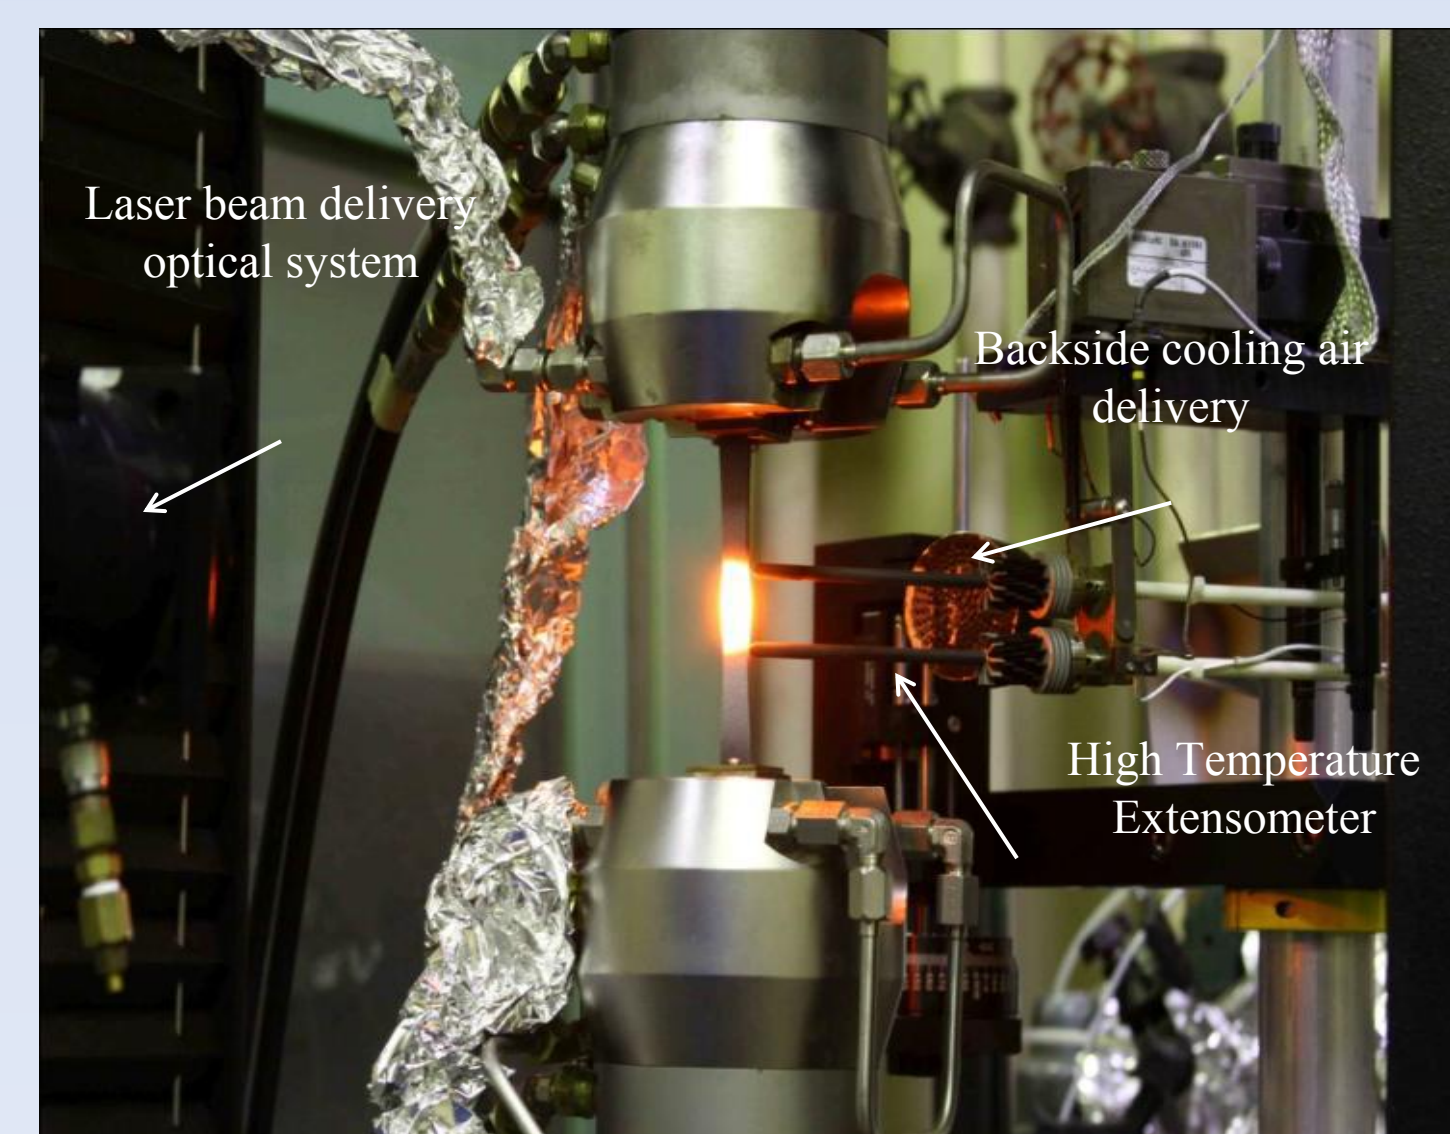
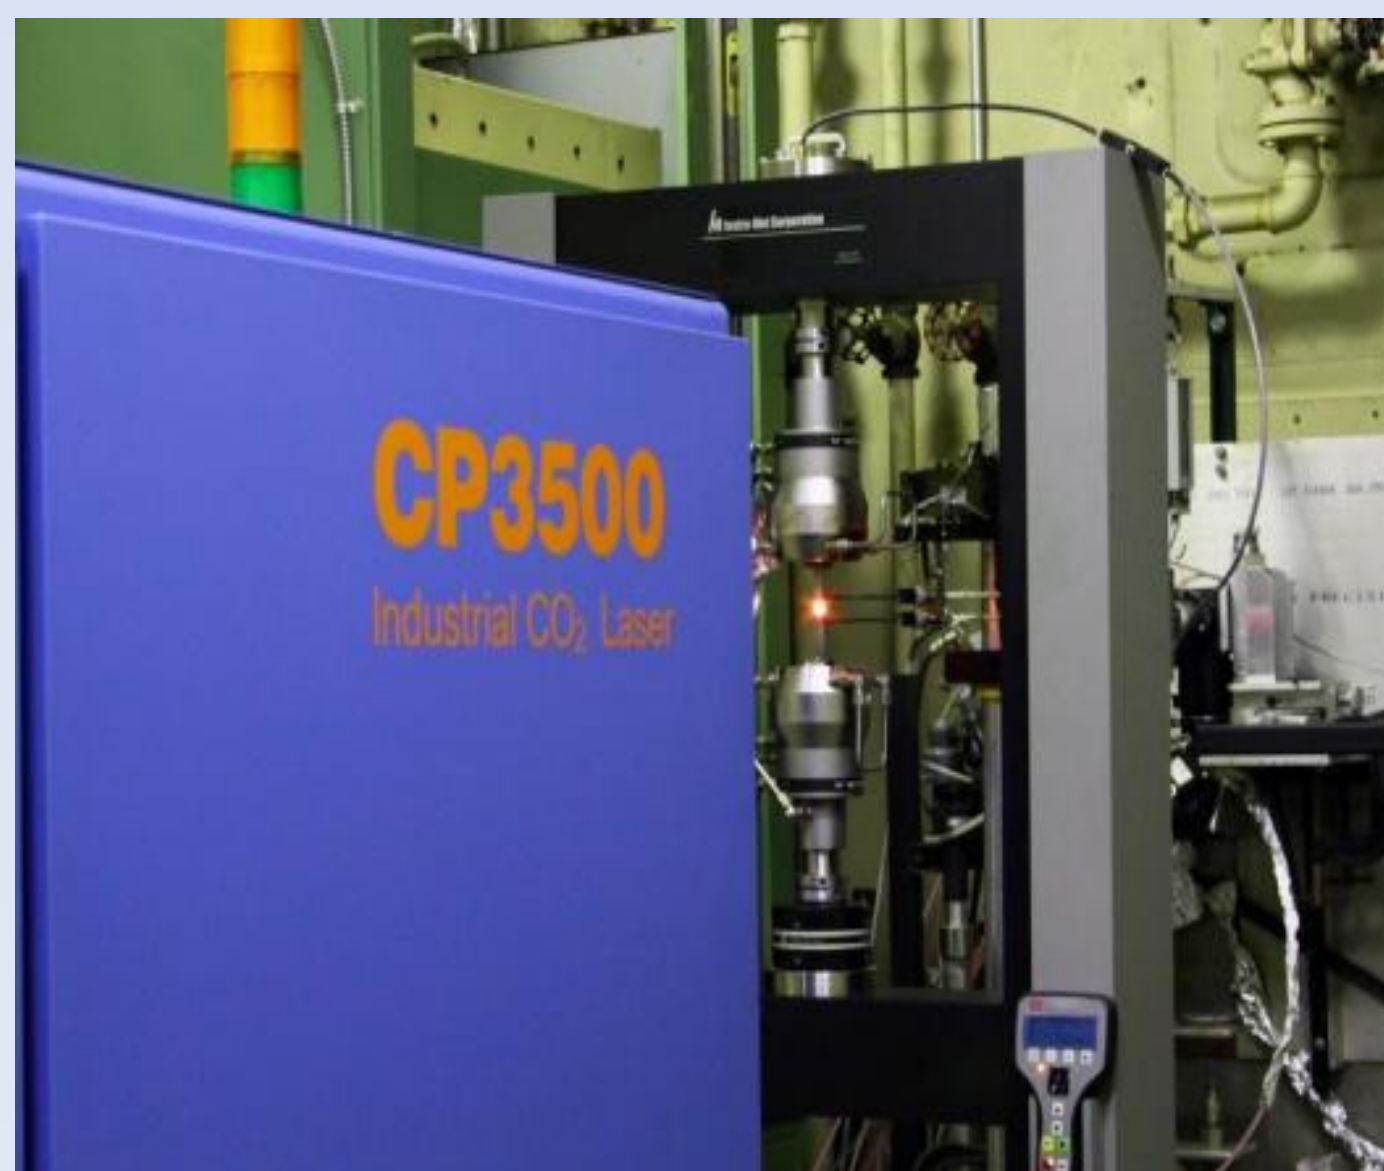
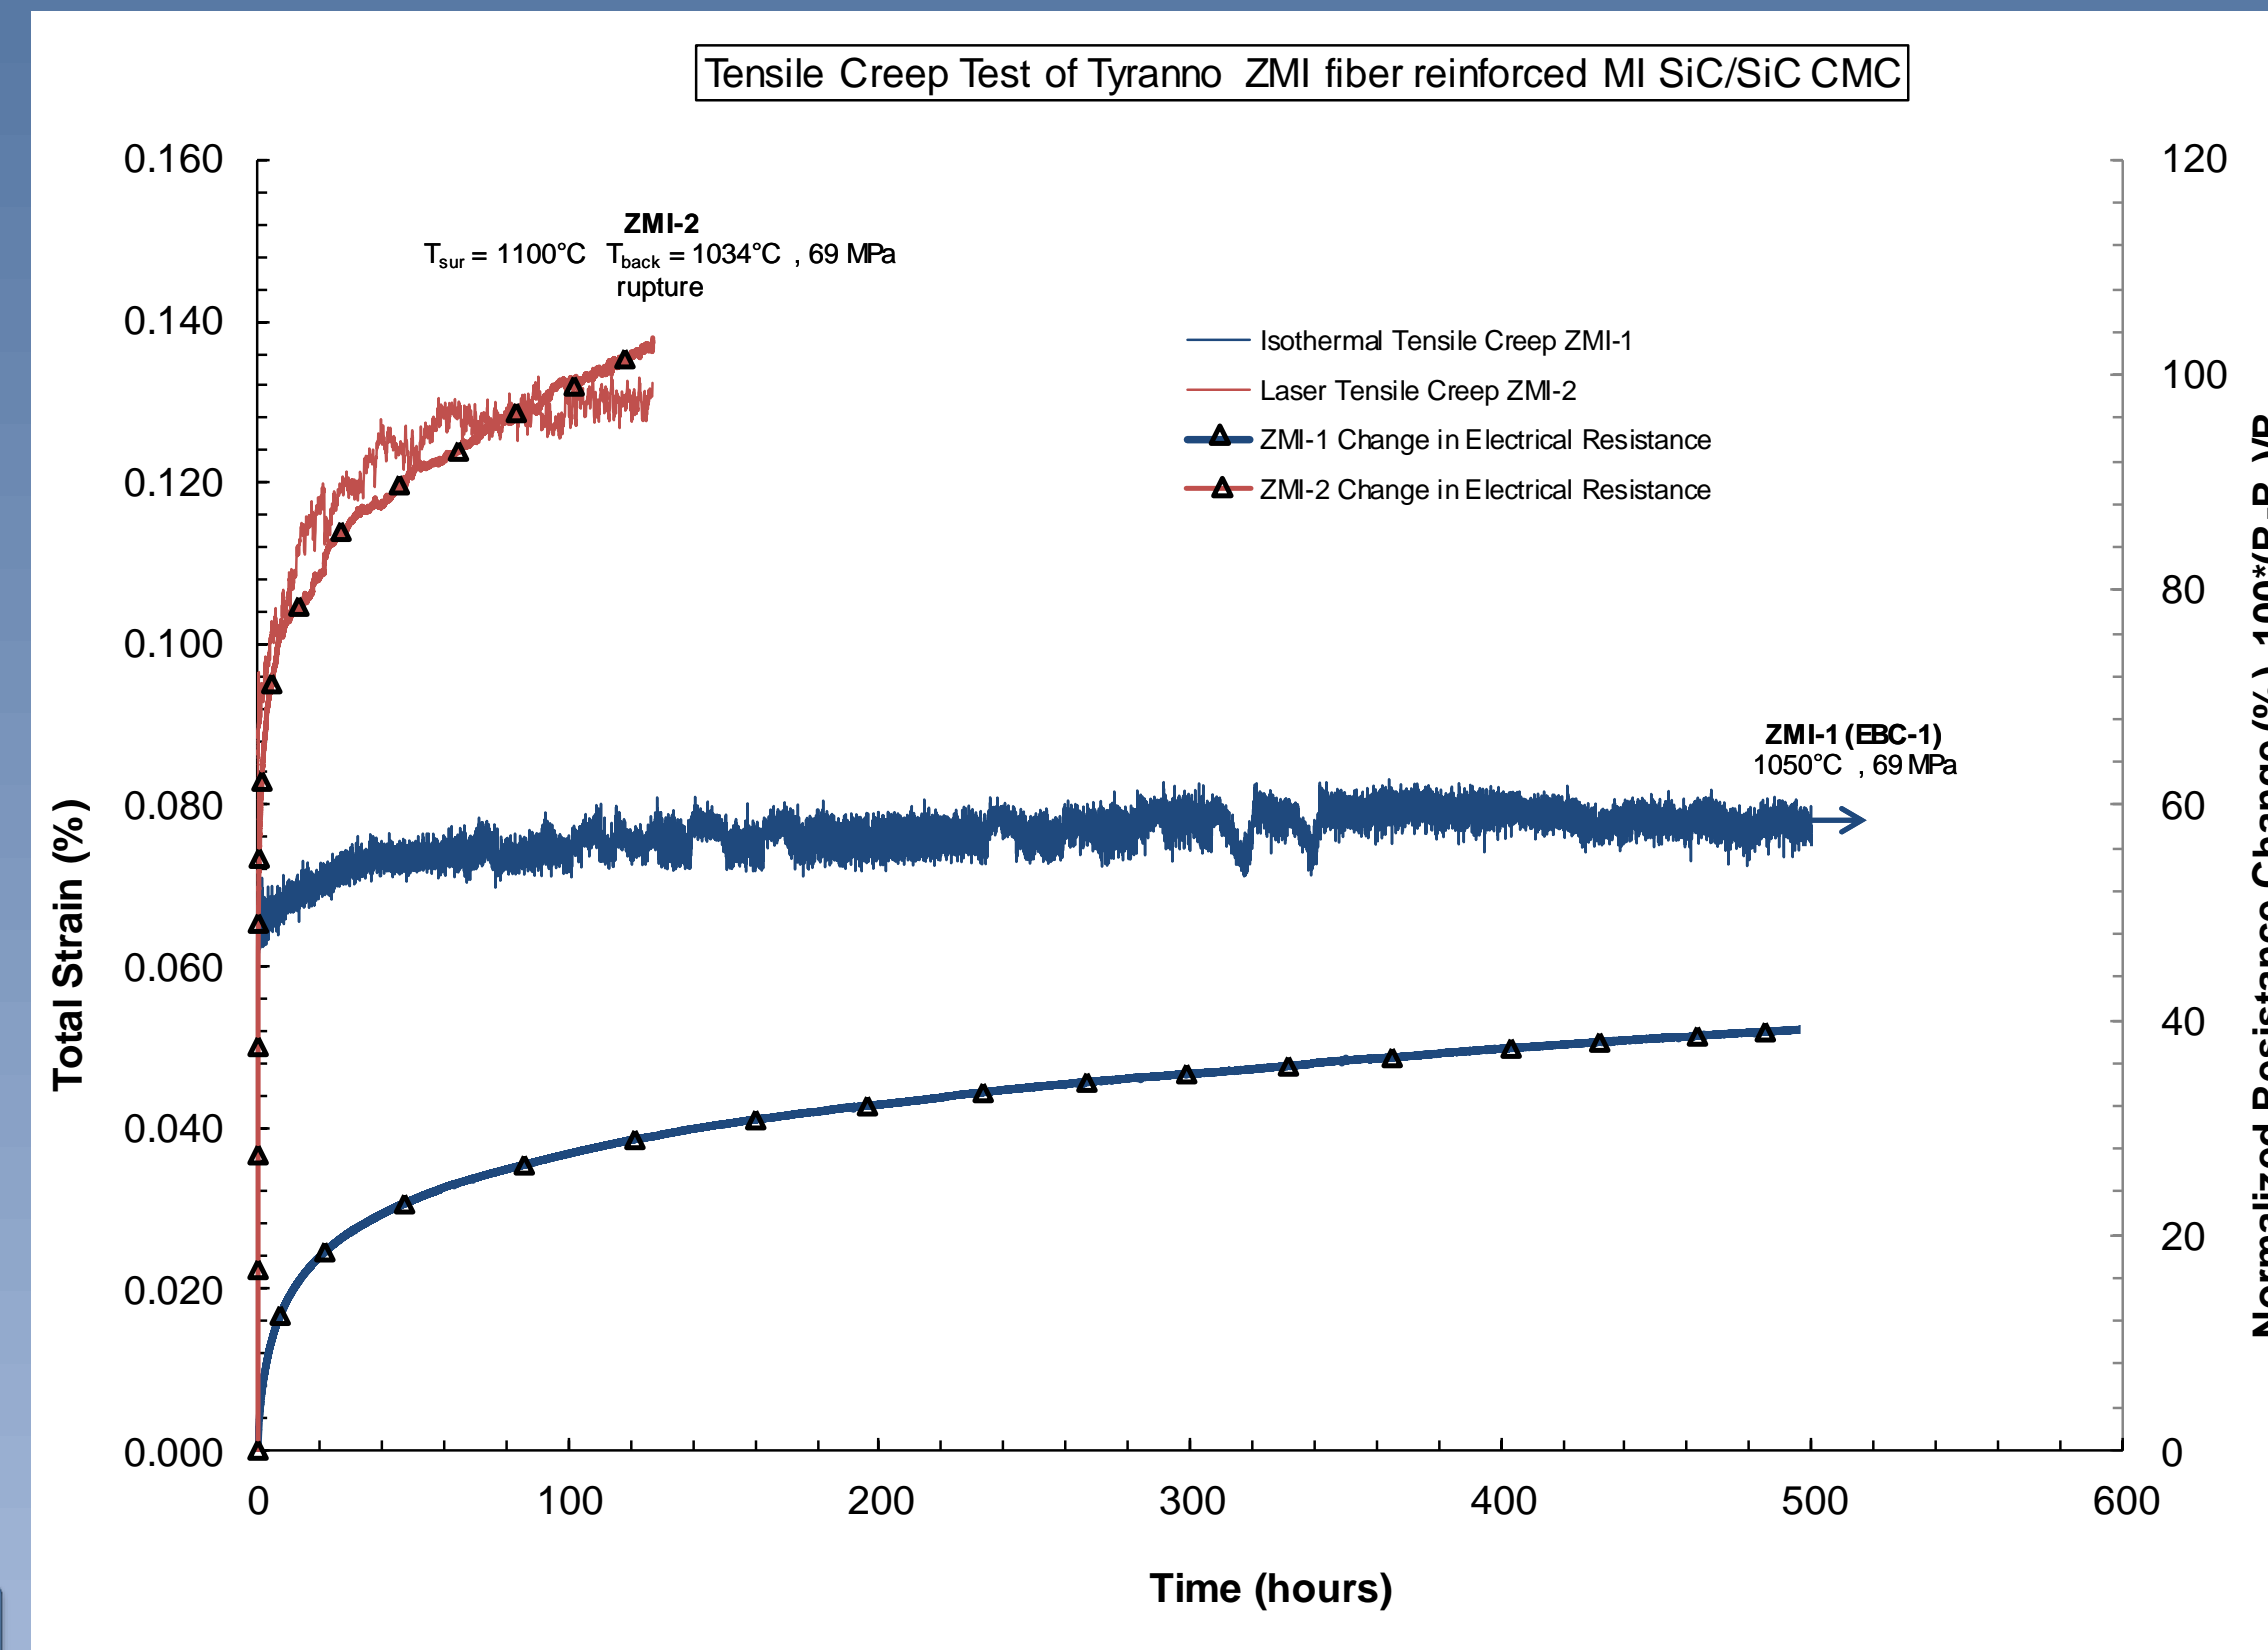
- The specimen surface heating was provided by a high heat flux CO<sub>2</sub> laser system.
- Using an integrated rotating lens a uniform laser power distribution is achieved the gauge region of the sample face.
- In order to induce the desired through thickness thermal gradient, controlled cooling air was delivered to the back side of the CMC.
- The front side and back side temperatures of the specimen were monitored throughout testing by an 8 $\mu$ m and two-color pyrometer respectively.

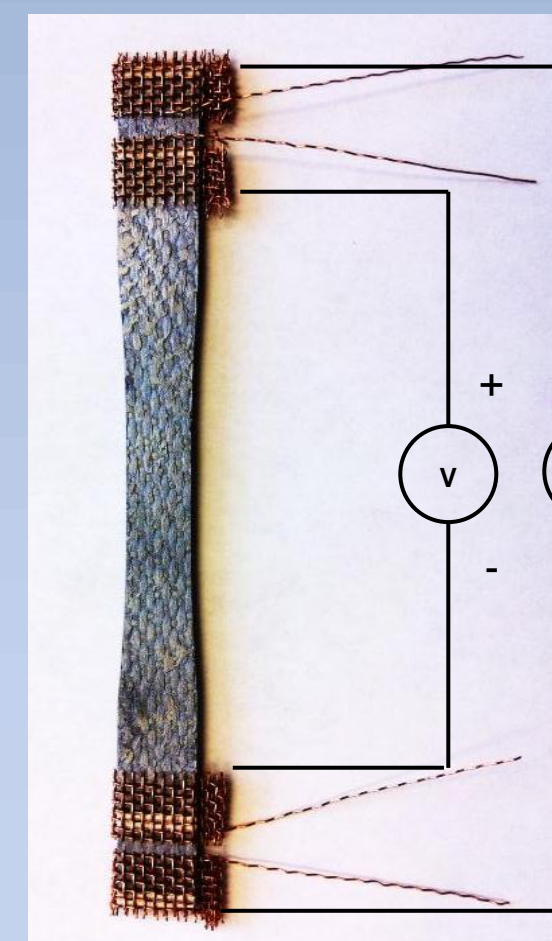
- In an effort to monitor and potential characterize the damage accumulated during testing in situ electrical resistance measurements were taken
- A four point resistance measurement was used in which electrodes were placed on the ends of the dog-bone specimens inside the grips.
- For both the isothermal and temperature gradient conditions the specimen was heated to a stable condition before the creep load was applied.

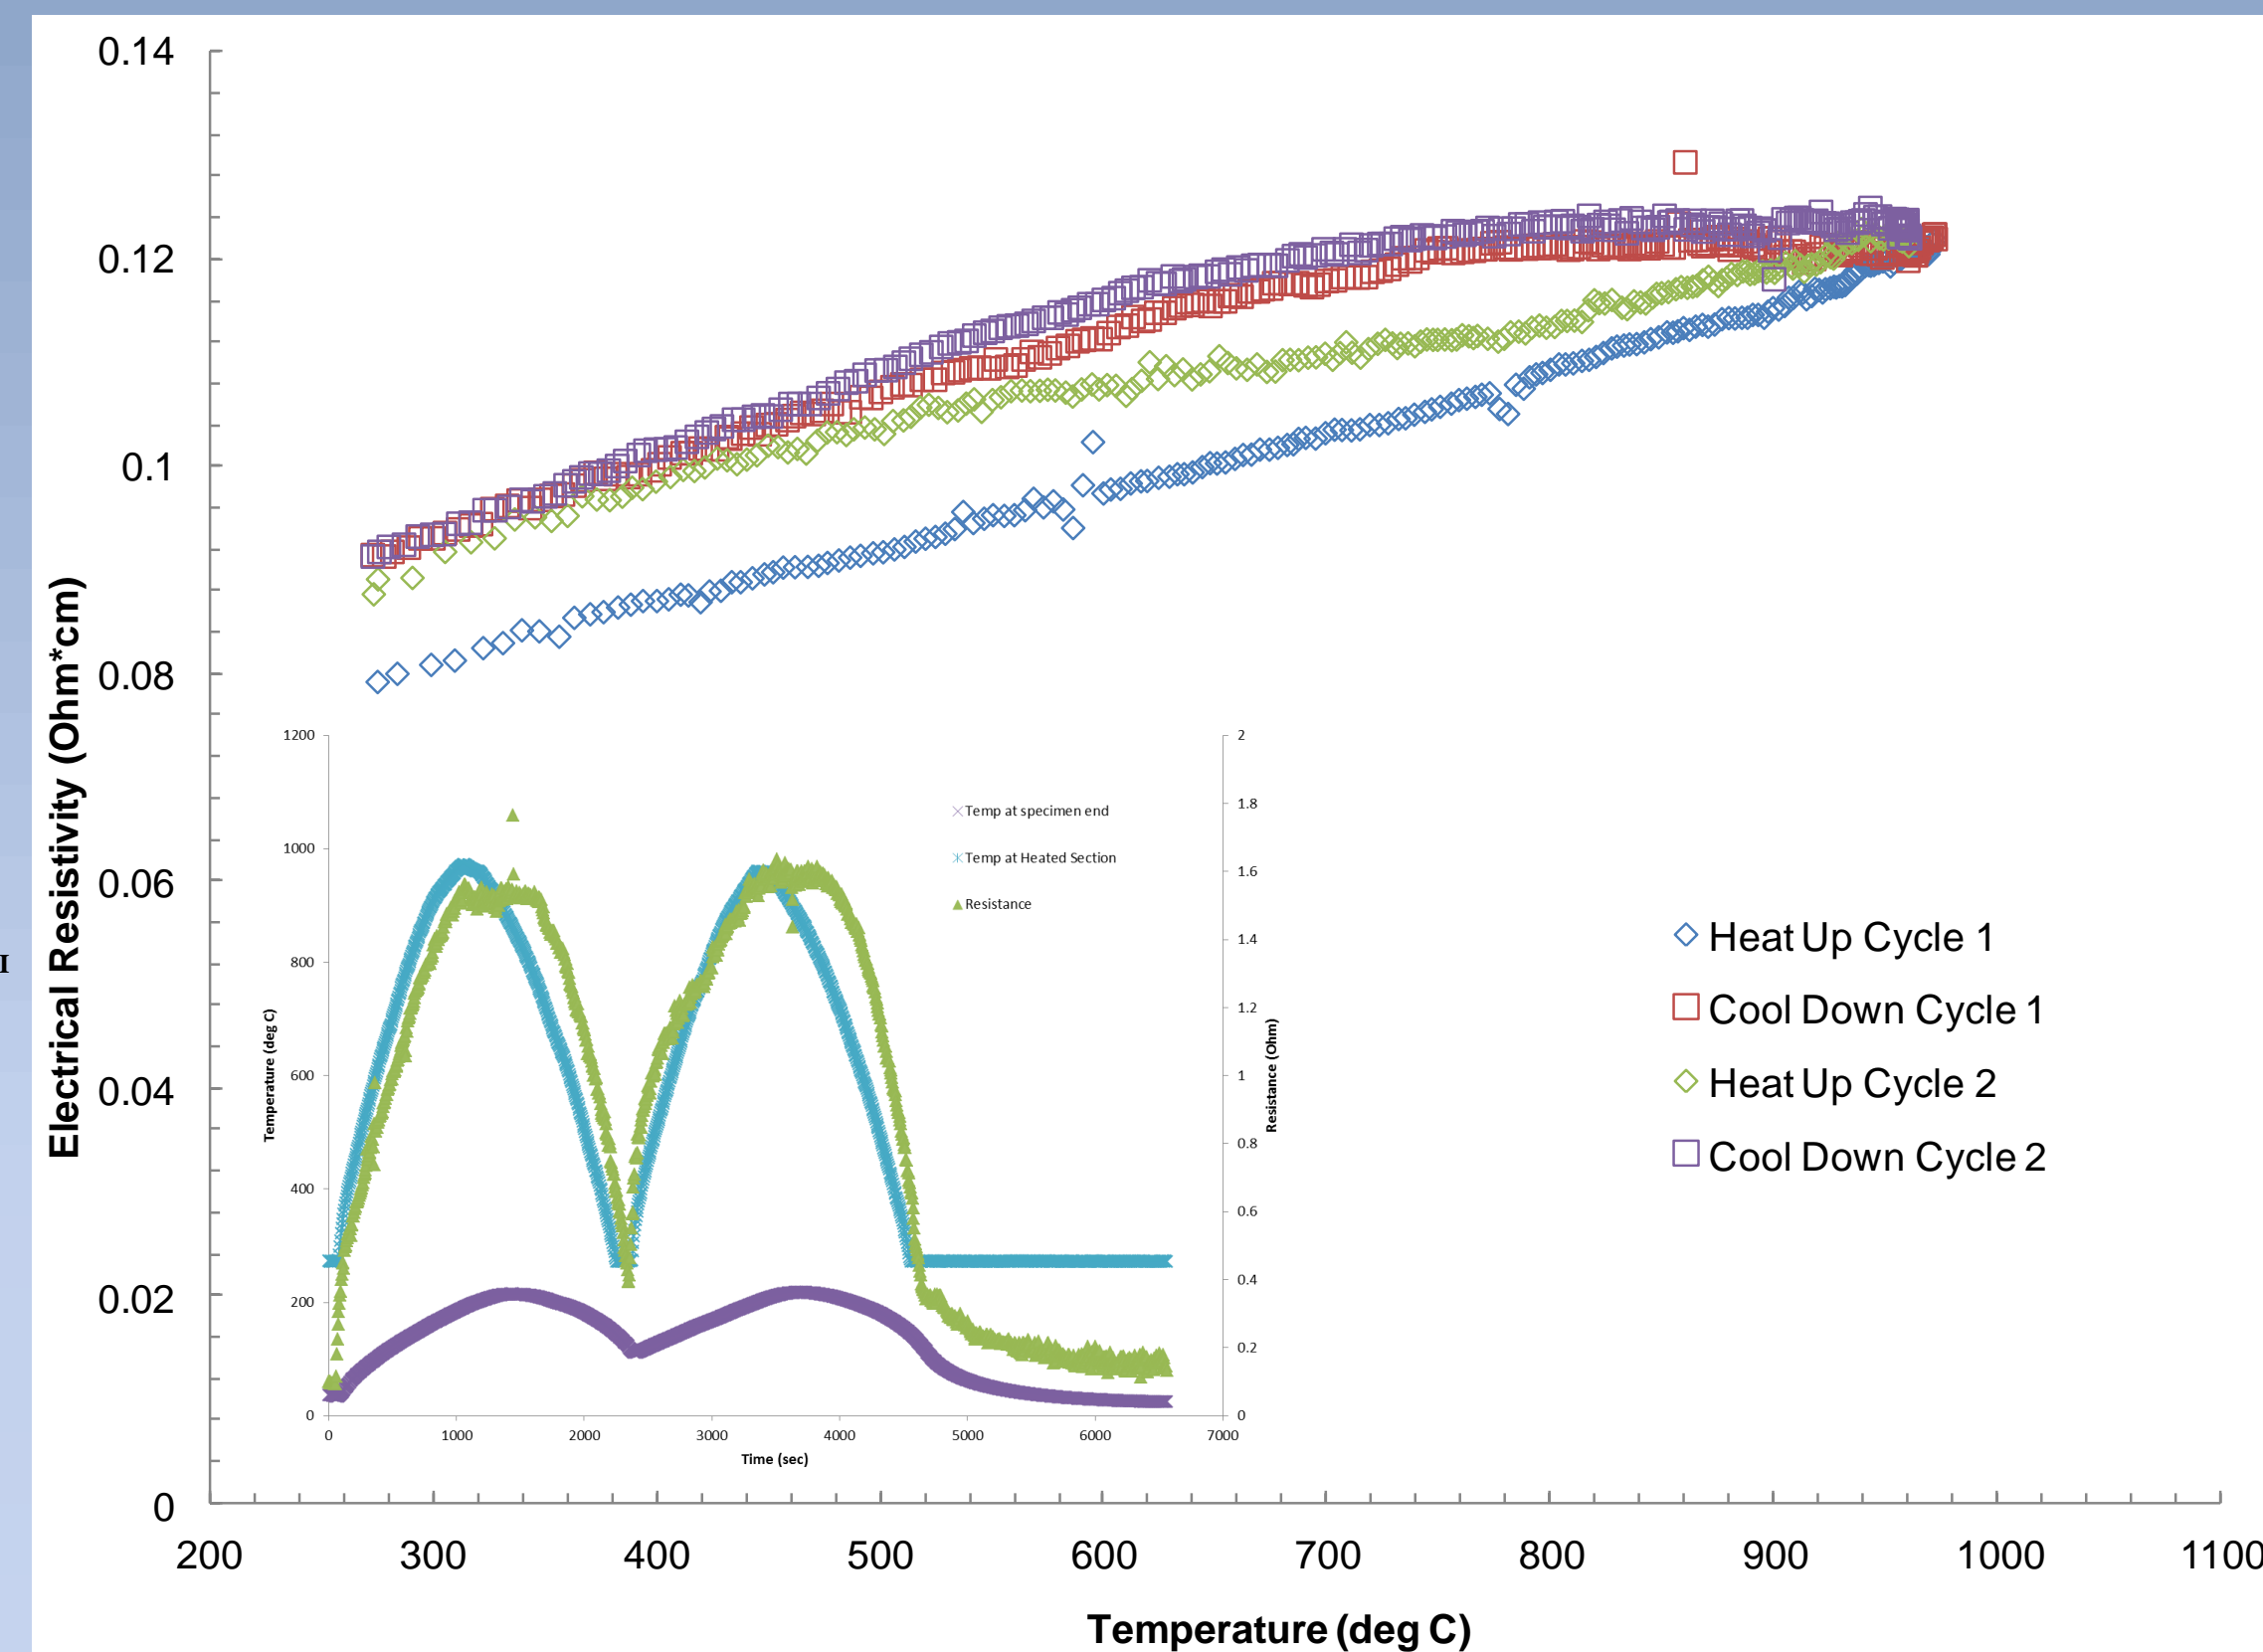
- In order to determine the sensitivity of the ER measurement during high-temperature testing The dependence of electrical resistance on heating was examined for an uncoated specimen.
- This test was performed in the absence of mechanical loading and will be used in future work to model the electrical response of the composite system to thermo-mechanical loading.

- The coupled ER measurements appear to be sensitive to both temperature increase as well as increased damage state of the material leading to confidence in its use as a non-destructive evaluation and damage modeling technique.

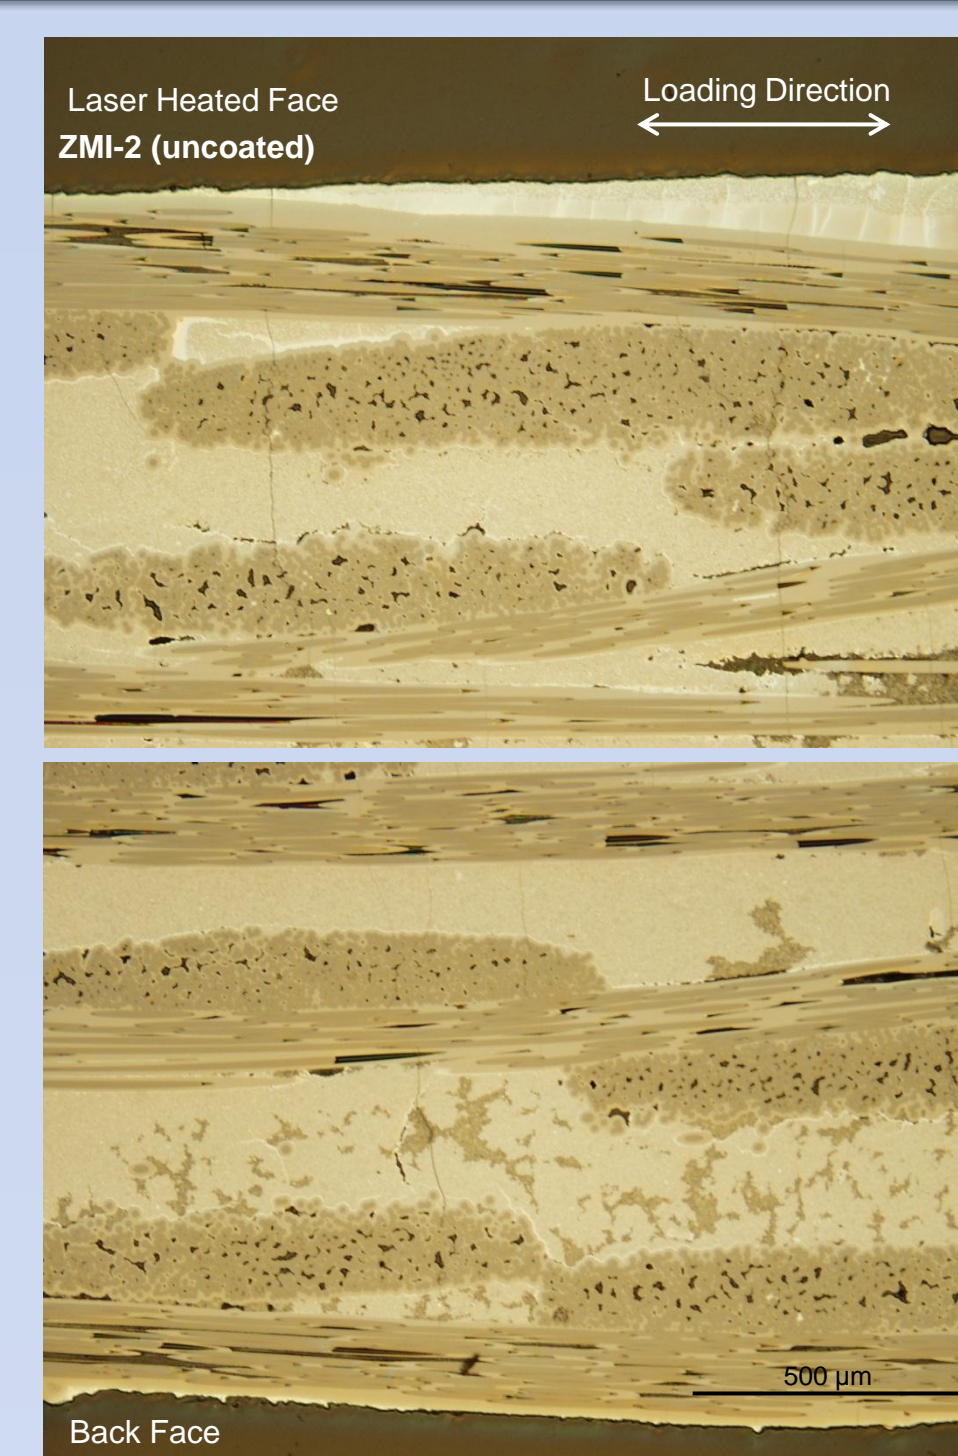
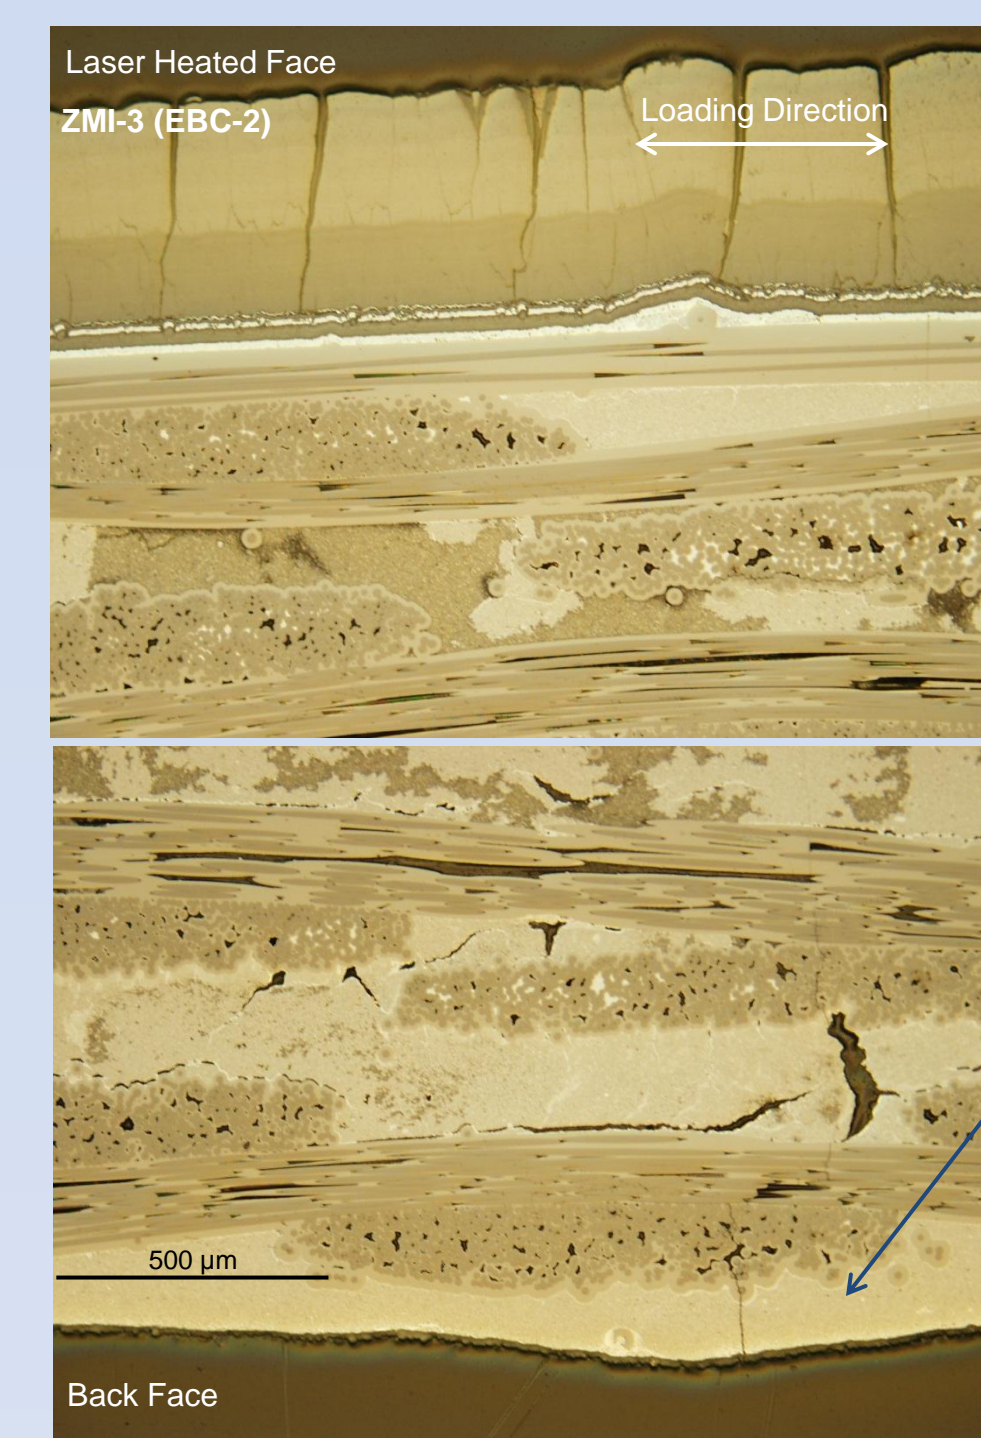
- Absence of thru-thickness cracking.
- Majority of surface cracks observed begin on the non-coated surface and do not penetrate very deeply.
